# Integration of Equipment Aging Influences on Water Quality Variation in Apartment Houses

Cheng-Li Cheng

Department of Architecture, National Taiwan University of Science and Technology

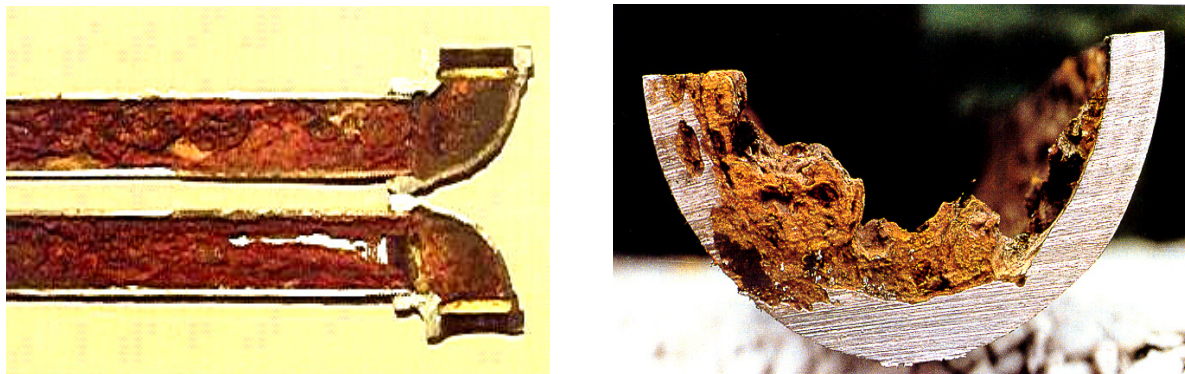
Figure.1 A general aging case for plumbing fixture

Field investigations were performed to determine the plumbing system-related issues in buildings. The first observation in Taipei indicated that the plumbing system in most apartment buildings is covered during construction with no access to the critical system junctions. Therefore, when the building is finished, the maintenance or repair of plumbing is very troublesome with no easy way to deal with failures or blockage in the piping and equipment. The only way to deal with a failure in the plumbing system is to tear down that portion of the building for repair or discard the entire system. This construction practice makes it impossible to modify or replace the system or any of its parts. The water supply piping will age after a period of usage. Metal piping material will become corroded. Current construction practices make it impossible to maintain or replace aging or damaged pipes and fixtures. When the water becomes polluted or major leaks occur, the building must be dismantled. Figure.1 shows a general aging case for plumbing fixture in current apartment building. In the past, designers did not consider the concept of building life cycle, and existing buildings had no explicit renewal schedule. In most renewal cases, as the investigation indicated, a worn or malfunctioning plumbing system is the major reason for the building renewal decision.

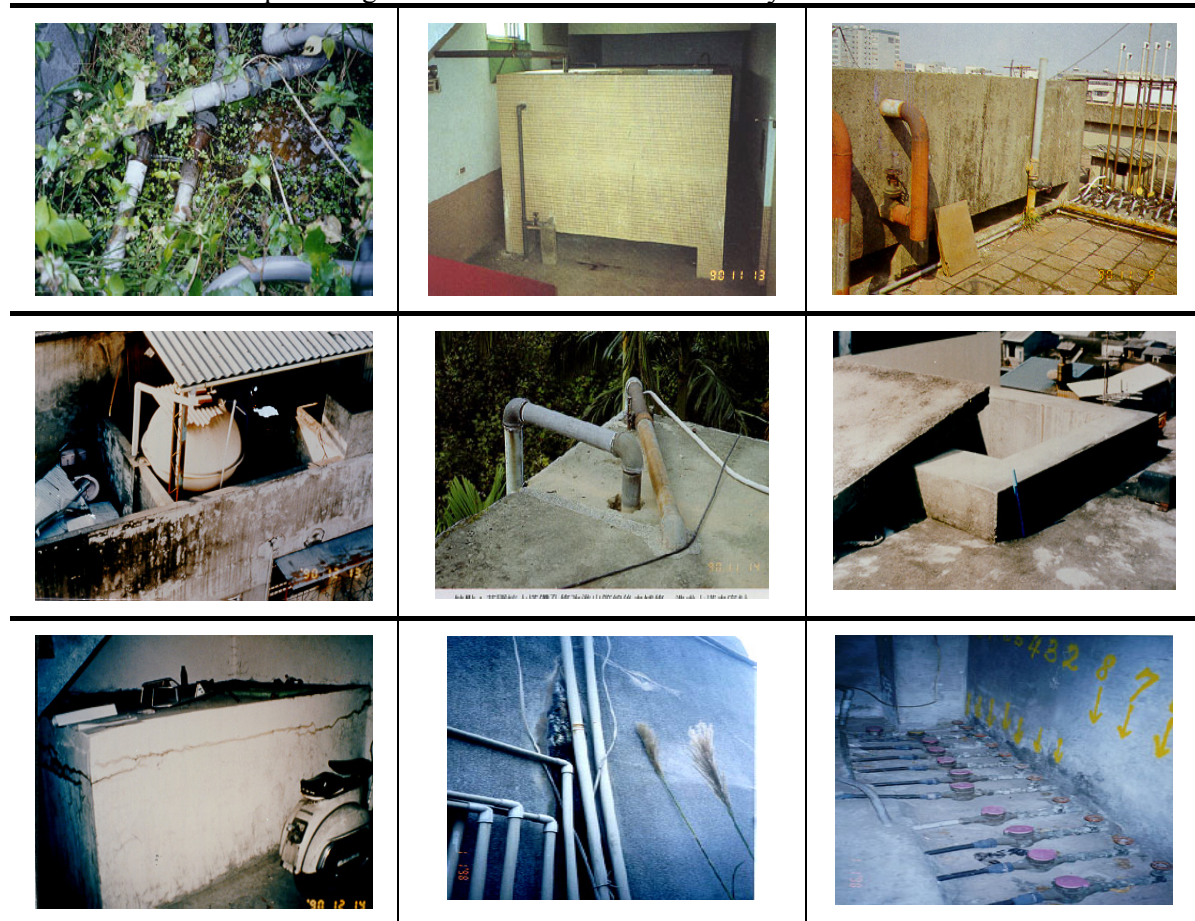
Table 2. Pictures of plumbing fixture situation in some survey cases

During this field investigation, 113 apartment houses in the Taipei area were examined. The investigation items included fundamental data on the building, elevated tanks, storage devices, piping systems and water quality. Table 2 shows the pictures of plumbing fixture situation in some survey cases. There are a lot of problems happened in practical building water supply system of apartment houses.

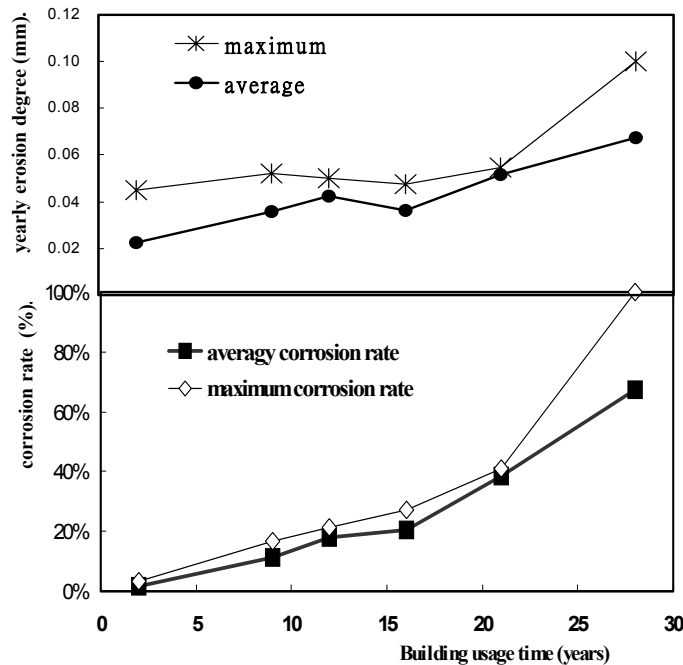
Figure.3 is a diagram that shows the relationship between yearly corrosion degree and number of years usage. As this diagram indicates, the number of years usage increases the yearly degree of corrosion. There is a slight increase of about 0.04~0.05 (mm/year) as the number of years usage is below 16 and a steep rise as the number of years usage beyond 20. According to existing documents<sup>[11]</sup>, the durability span for galvanized pipe is about 15~20 years, which closely agrees with the result of this survey. The same diagram indicates that the corrosion rate is less than 20% as the number of years usage is within 16 and near 40% as the number of years usage goes over 20. Note that the corrosion rate varies and will increase year by year. The remaining life span of pipe will decrease in reverse proportion to the corrosion rate. Aside from water transportation and supply, the function of piping systems is to prevent water leaking. In general, the secure durable life span for galvanized steel pipe could reach 25~30 years. In order to avoid leaks, the usual practice is to subtract 5 years for assessment reference. According to the interior diagnosis study, aged piping would pollute

the supply water and produce leaks, consequently, an existing building must have the function and security of its piping system checked after 15~20 years usage.

Figure.3 Relation of piping corrosion and building usage time
